# Finding of Necessity

Lauderhill Southeastern CRA

Produced by:  
EDSA &  
Carras Community Investment, Inc.

September 28, 2018

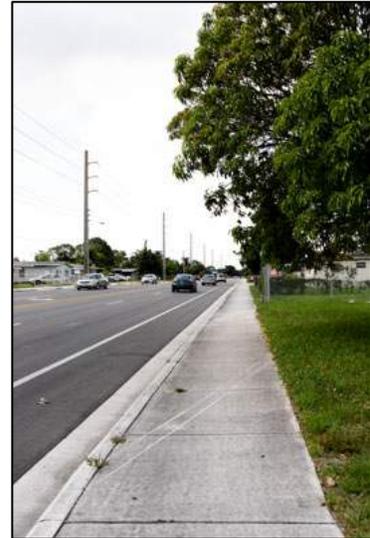
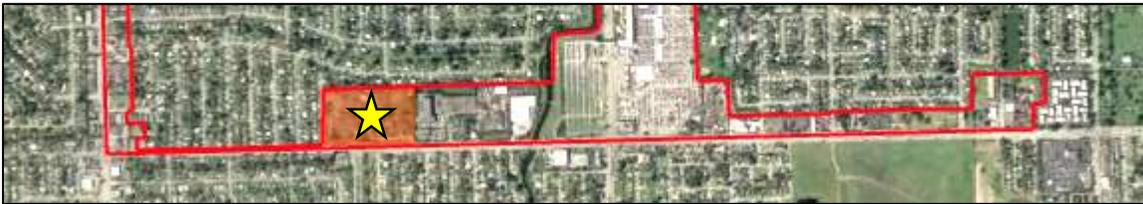
Figure 11. Martin Luther King Elementary

Pedestrian facilities are inadequate and unsafe. The sidewalks are narrow and perilously close to speeding vehicles. There are no barriers (natural or artificial) between pedestrians and the street, which creates an uncomfortable and dangerous situation for the non-vehicular traveler.

The dangerous pedestrian conditions are particularly alarming considering that Martin Luther King Elementary School is located on 591 NW 31<sup>st</sup> Avenue. Roughly 480 students attend this school, many of them walking or biking from the surrounding neighborhoods.<sup>7</sup> Children on their way to school are forced to use dangerous sidewalks and cross large intersections prone to vehicular accidents, as described in the previous section.

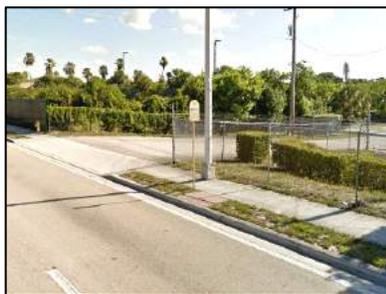
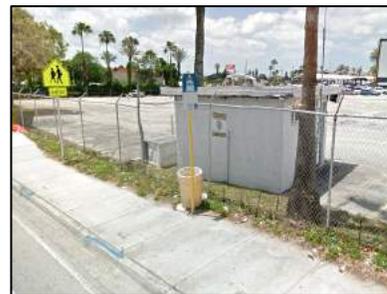
The study area is served by the Broward County bus system and Lauderhill Community Bus Shuttle. While there are numerous stops in the study area, bus service is intermittent, and waiting stations are often completely exposed to the elements.

Bus travelers must endure harsh conditions, including high heat, thunderstorms, rain, and hail. The bus stations provide limited shade and protection from the elements, and bus travelers are often forced to wait in lawns, under trees, or at nearby businesses.

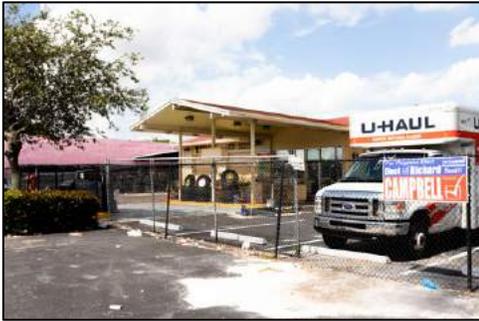
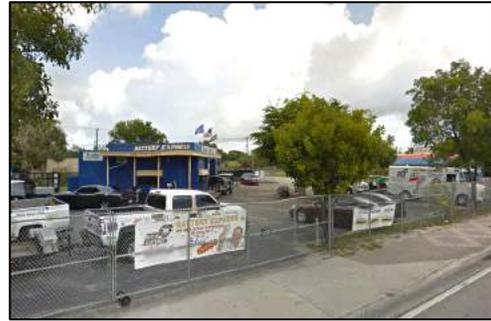
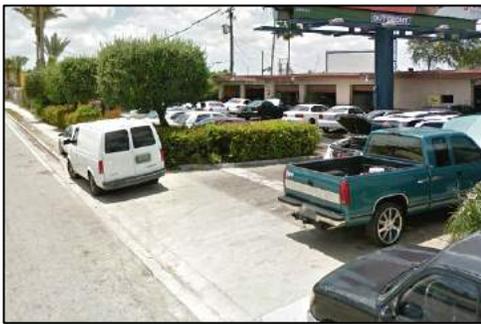
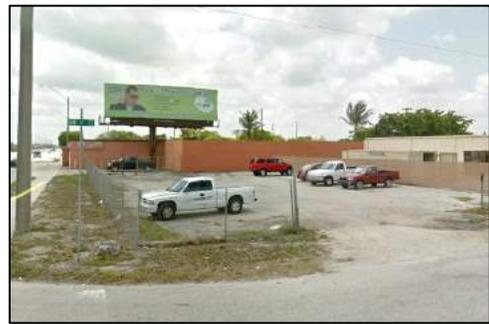
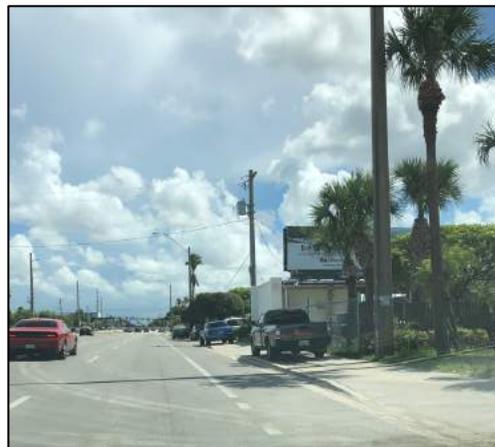
Numerous parking facilities are inadequate or in need of repair. In numerous circumstances the asphalt is crumbling, striping is indiscernible, and parking stops/bumpers are not at the end of parking spaces. Few parking lots have landscaping, and many of the auto service facilities have overflow parking on the sidewalk and in the street.

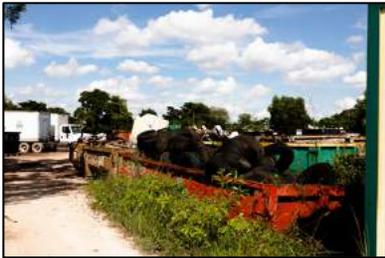
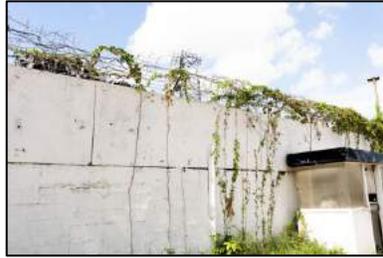
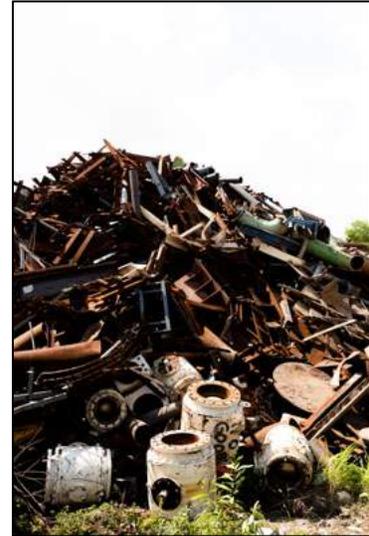
The study area contains unsightly and unsafe junkyards, scrapyards, and automotive repair facilities. These facilities are clustered along Northwest 31<sup>st</sup> Avenue, which exacerbates an already dangerous use and compounds deleterious environmental conditions.

These facilities often have poor lighting, are bordered by fences and barbed wire, have unsupervised alleys, and appear to contain large quantities of environmentally dangerous materials.

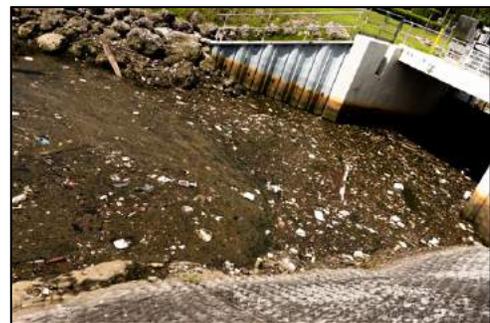
Water runoff facilities contain trash and debris. These facilities are not only unsightly but appear dangerous and unsanitary. Storm water collection facilities are in need of upgrades and routine maintenance. While pollution monitoring and collection are outside the scope of this study, the site survey found several instances of what appeared to be environmental hazards and water facilities in critical condition.

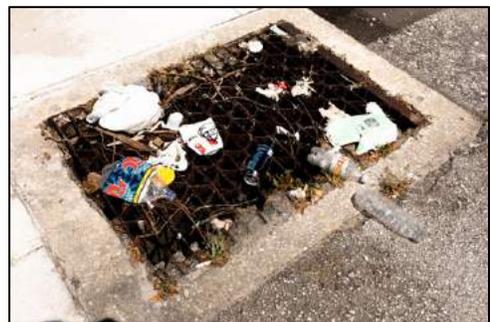
Street drainage systems also appear to be lacking routine maintenance. Gutters have accumulated large amounts of garbage, which slows water dispersion during periods of high precipitation. This garbage also accumulates in front of businesses, along sidewalks, and other locations frequented by customers and residents, which reduces "curb appeal" and can hurt commercial foot traffic.

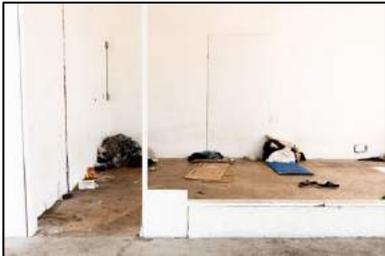
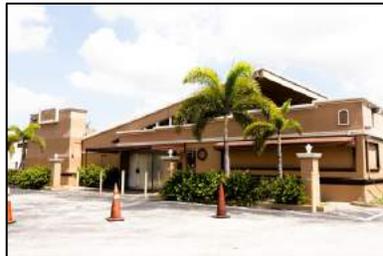
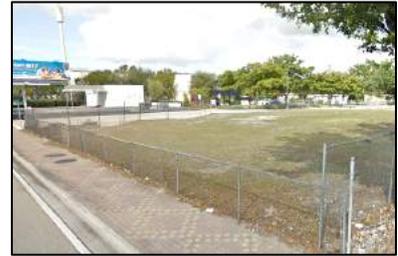
Abandoned lots and buildings are unsightly and dangerous and have noticeable site deterioration. Homeless individuals appear to be residing in or around the structures of several buildings, producing unsafe conditions for the individual living at the facility and the surrounding community. Several abandoned lots on Broward Boulevard are littered with waste and lack adequate maintenance.

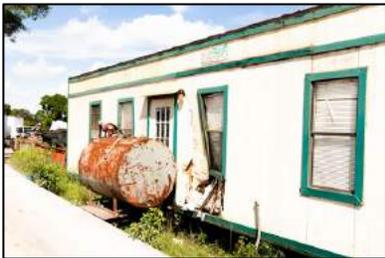
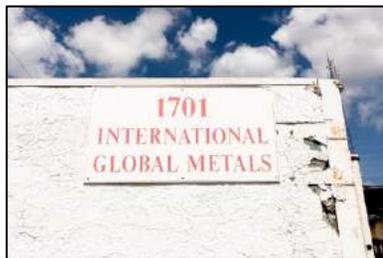
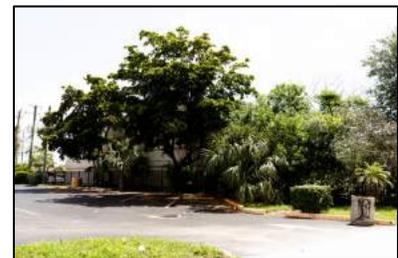
Several buildings and parking lots have fallen into disrepair. Not only do these structures exhibit decay, but many appear unsafe. It is questionable if these structures should even remain in use.

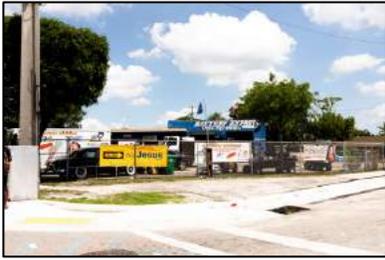
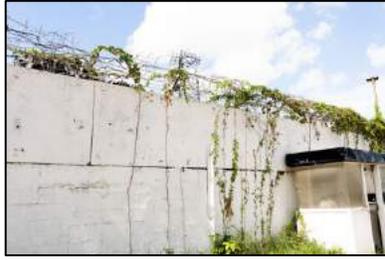
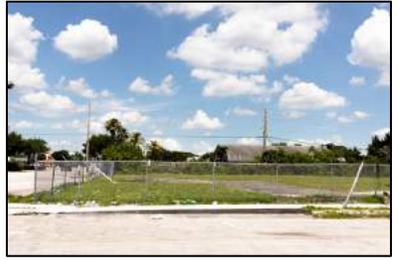
Poor fencing is another indicator of blight. Many of the structures in the study area are junkyards, scrapyards, and automotive repair facilities, which typically have walls and fencing. Many of these fences are in failing condition. Several abandoned lots also contain fencing that is unsightly and in disrepair.
