CITY OF LAUDERHILL - 105421
Inspection/Evaluation dated 11.12.2019

16" Class 150 GBZ Valve S/N: 62550
Original SO 99124 dated June 1999

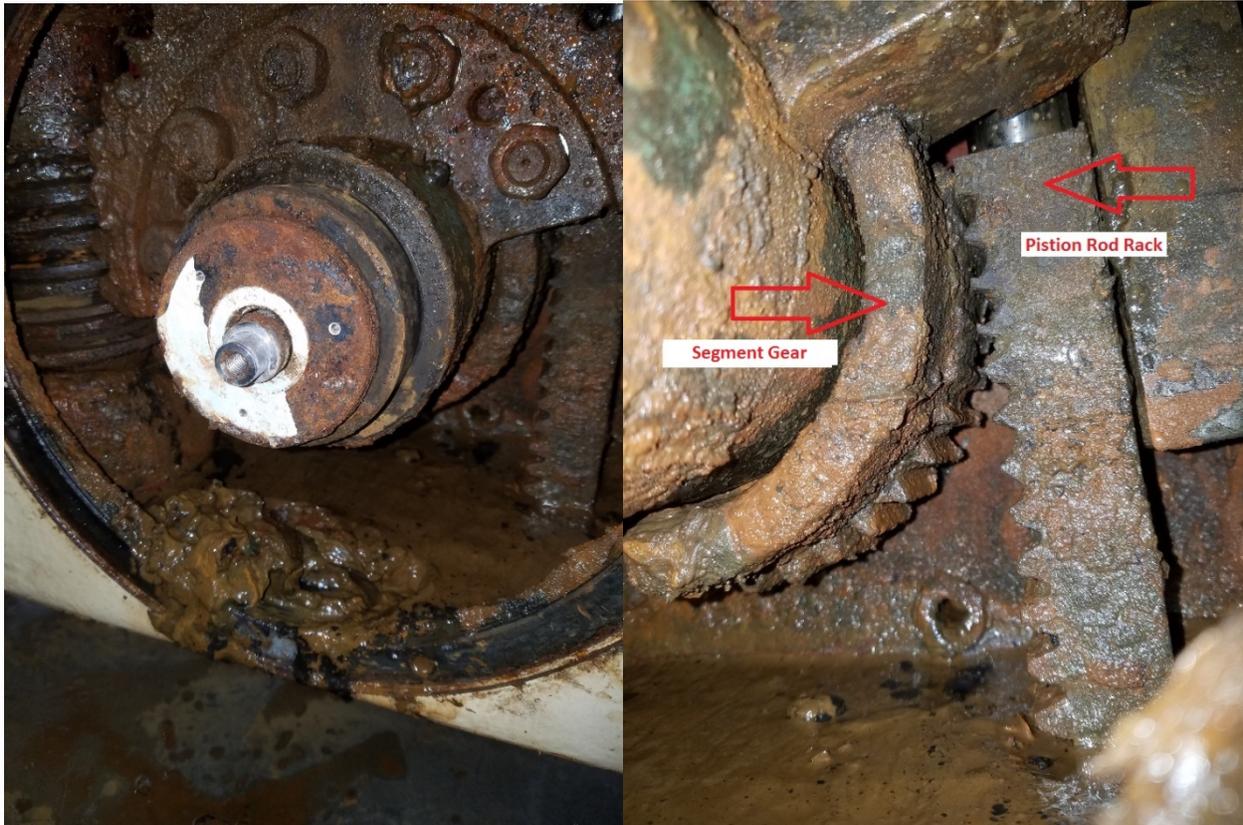
Gearbox and Hydraulic Cylinder

The above photos show the condition of the Piston Rod Rack and Gear Segment. These components are vital to the valve performance. In its current state the hydraulic damping is inoperable.

- Piston Rod Rack and Gear Segment are severely damaged due to corrosion.

Recommendation would be to replace the complete gear and hydraulic cylinder.

Due to the severe amount of corrosion damage found to the gear, hydraulic cylinder, valve body and disc it would be highly recommended that the valve be replaced and not repaired. The cost of repair would be greater than the cost of a new valve.

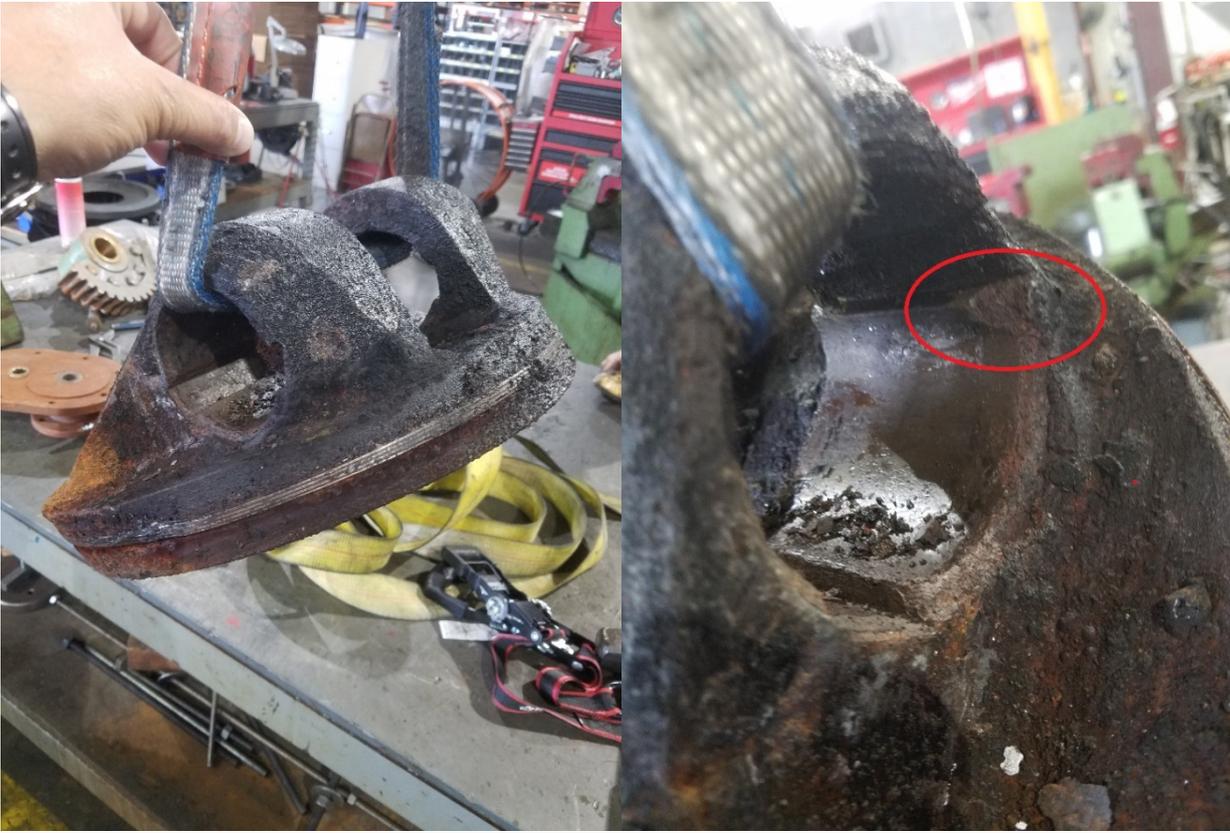
Valve Disc Inspection

Extensive corrosion to disc found. Top right photo shows part of disc shaft bore breaking off during disassembly due to heavy corrosion.

The valve disc will be sent to sandblasting and further inspection will be required to determine disc integrity.

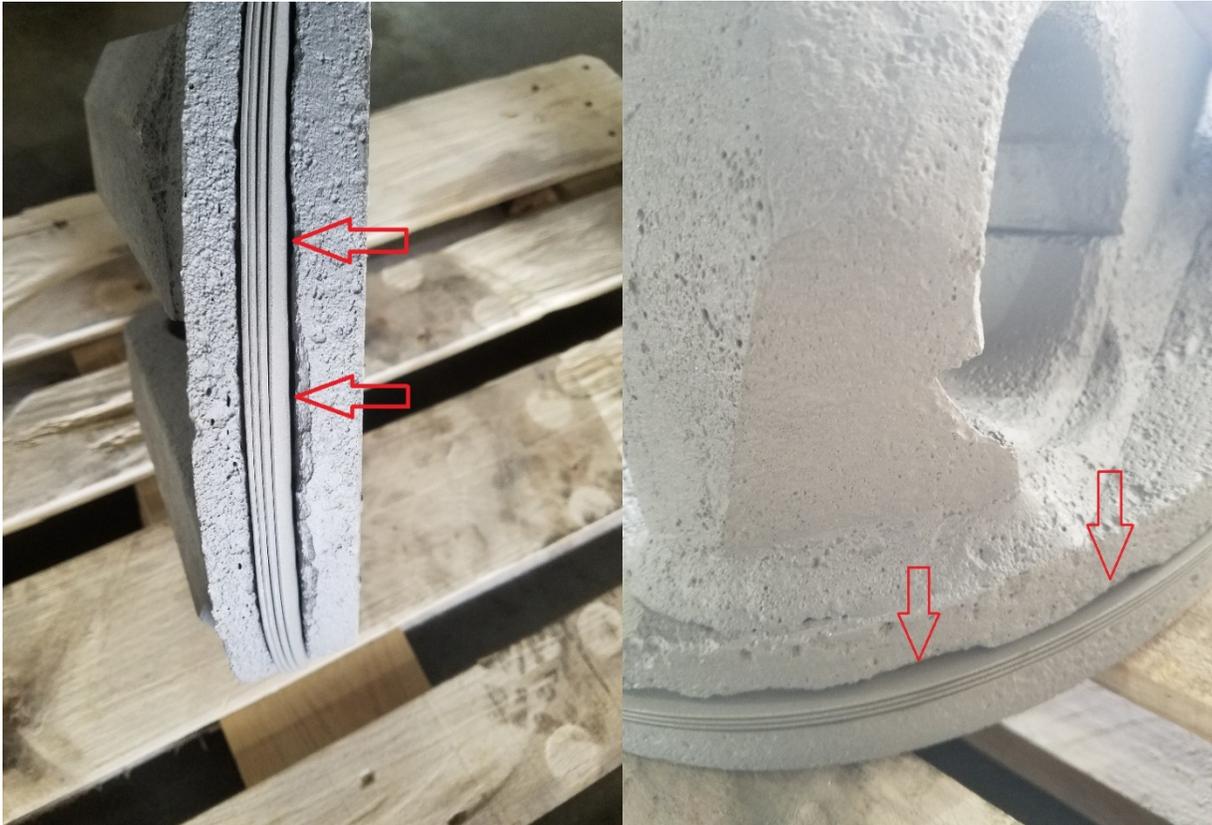
Continuation of Disc Inspection

Above right indicate significant material loss to the disc sealing surface. This surface supports the disc laminated seat and seal gasket

Disc is not reusable.

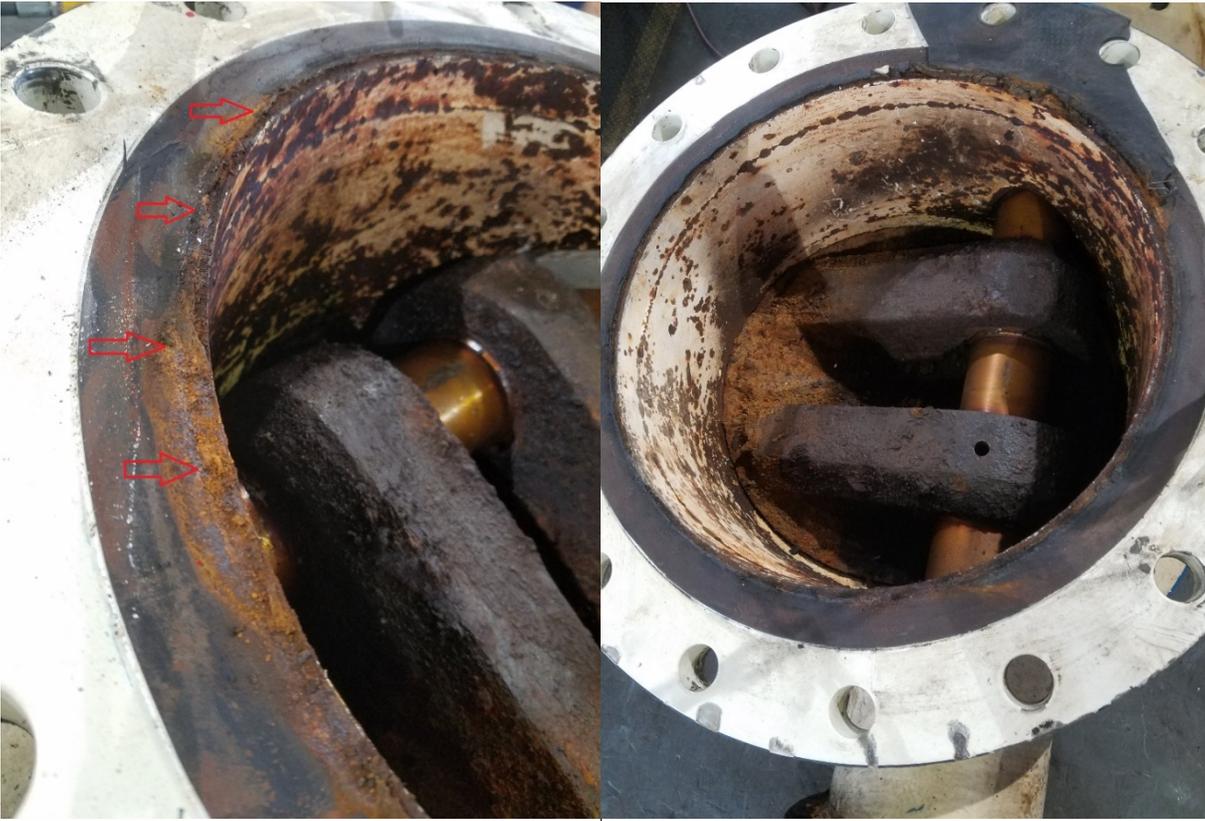
Valve Body inspection

The flange raised face sealing portion has severe corrosion damage to both side of the body. The affected areas will require machining, weld build-up and re-machining of the flange sealing surface.

The valve body and disc shown top right require re-coating to prevent further corrosion.

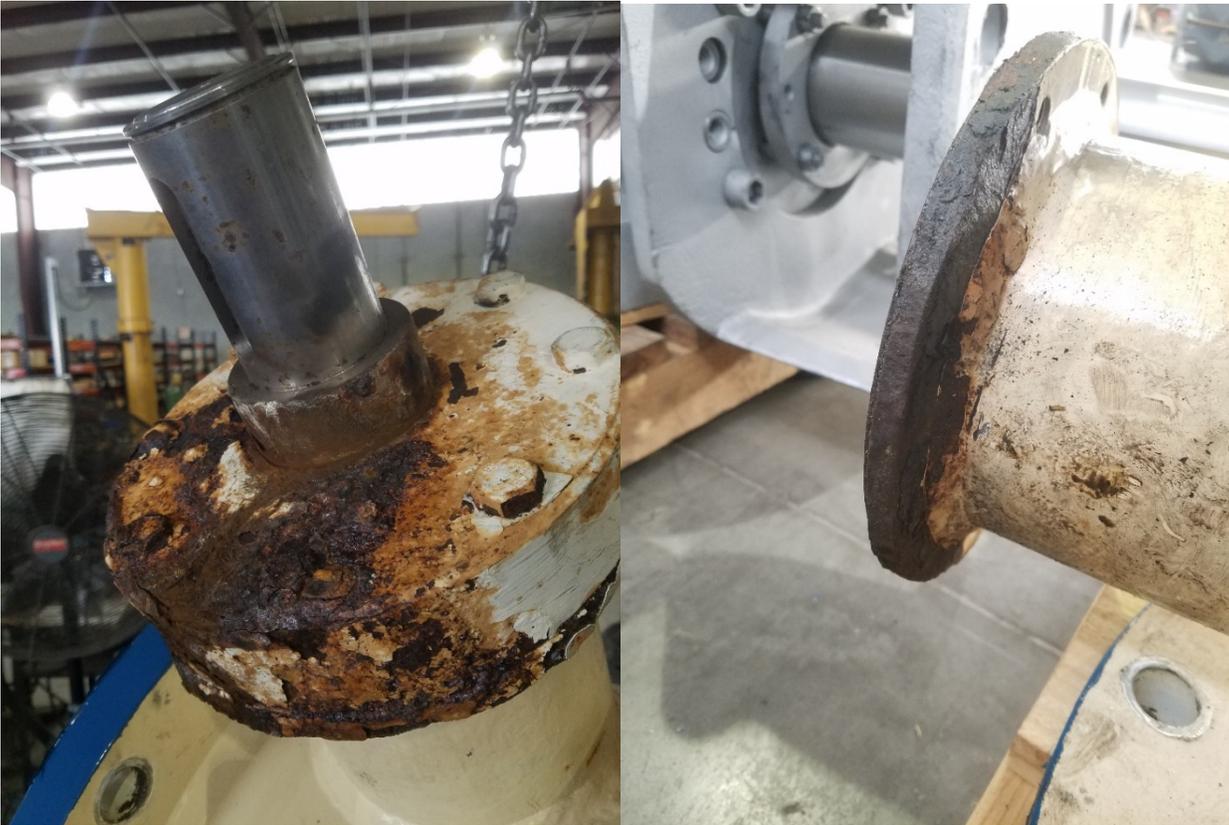
Continuation of Valve Body Inspection

The above photos indicate the non-drive side of the valve. The top left is an “as received” photo which shows heavy corrosion caused by the shaft seal leaking over a considerable amount of time.

The top right photo shows material loss due to corrosion on the valve body cap flange. The cap is secured to the valve body by (8) bolts which houses the thrust bearing and retains the valve shaft.

Material Loss Due to Corrosion: .118”
